# THE NATIONAL SOCIETY OF MASTER THATCHERS

## HOW LONG WILL THATCHED ROOFS LAST? - MANAGING EXPECTATIONS

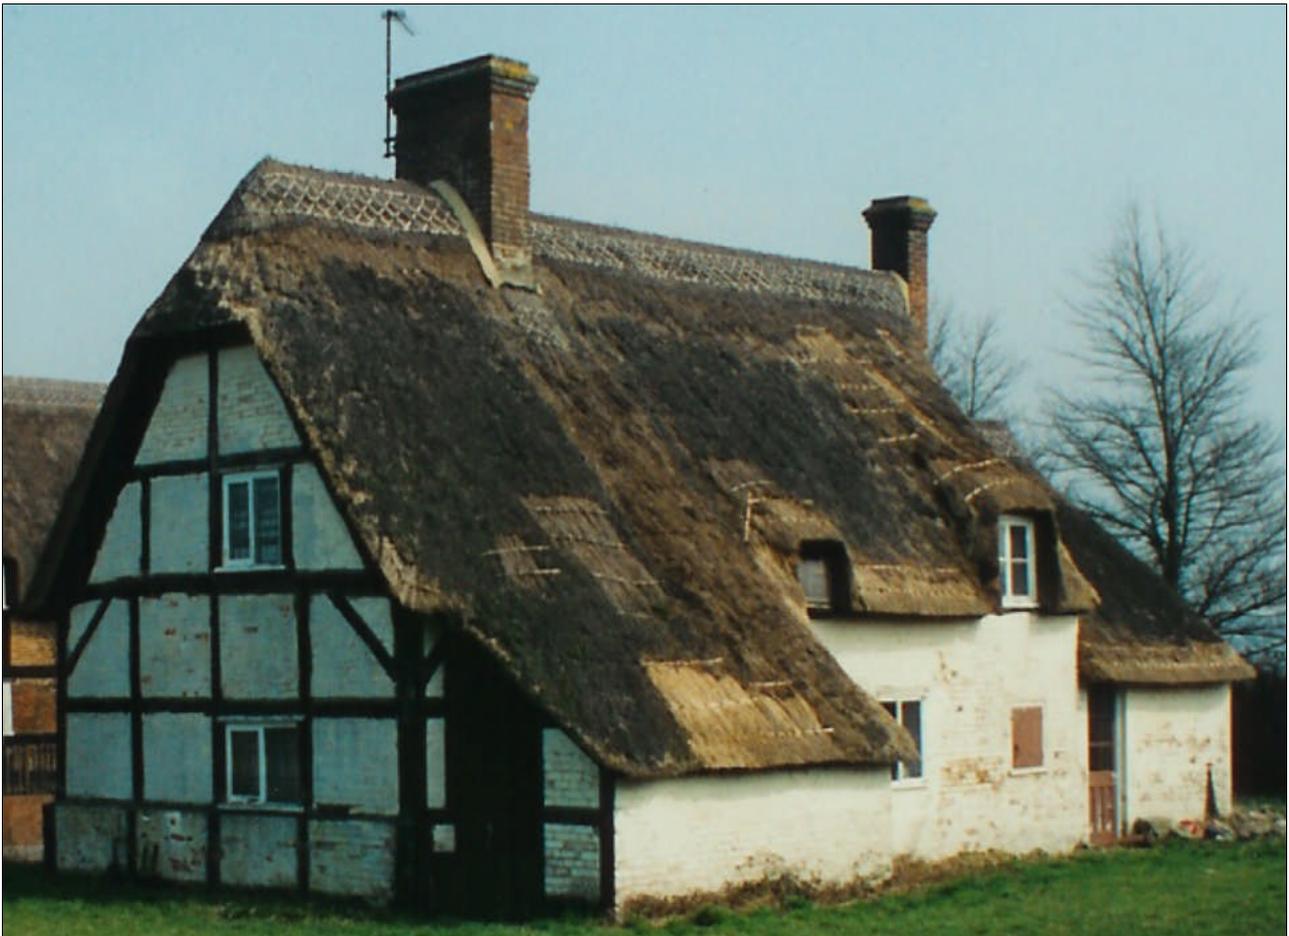
*Traditional annual patch and repair on a National Trust property. Few owners nowadays want their thatch to look like this, although it would have been the norm a couple of generations ago.*

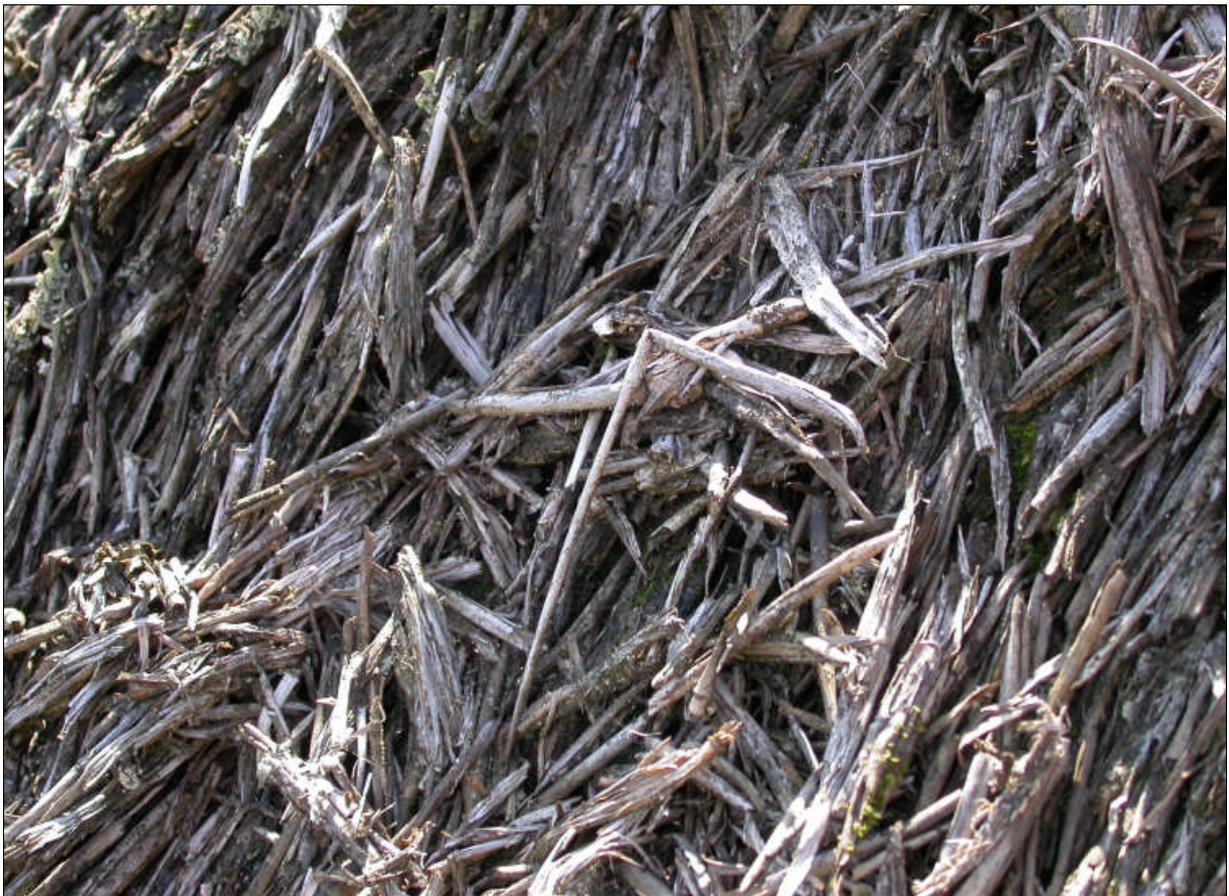
*Physical wear on a straw thatch. Algae formed a biofilm on the thatch in the winter and a dry summer has caused the film to contract. This has caused tearing and breakage of the butt ends of the straw*

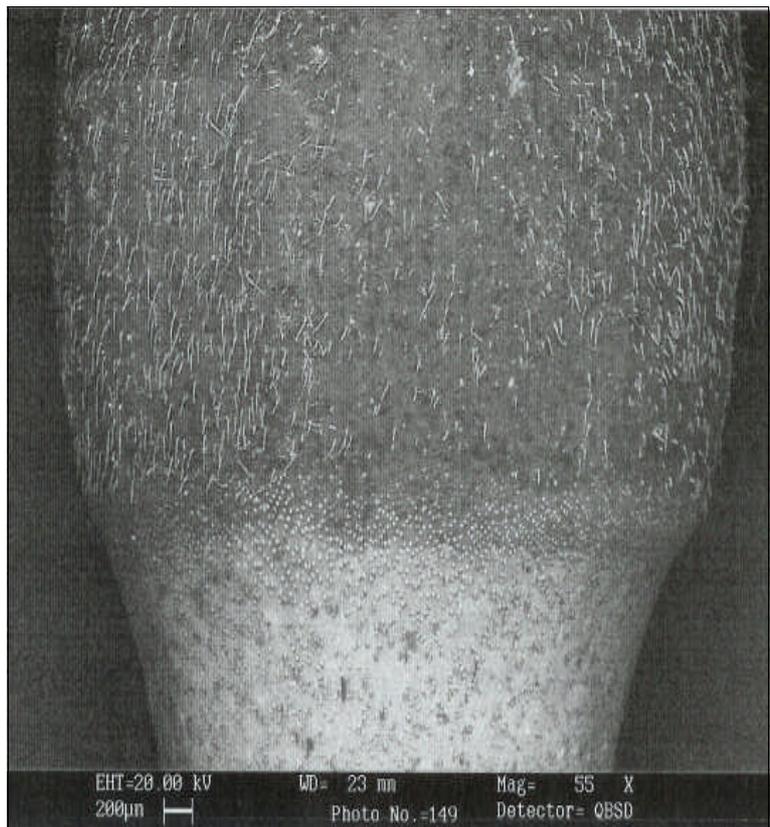
*Fig. 41. Scanning electron micrograph of the node (joint) of the stem of thatching wheat Maris Widgeon at harvest.*

An early indication of the potential for straw thatch degradation is fungal breakdown of the nodes. Nodes are the strengthening points in a growing stem and are the point from which leaf sheaths develop. In thatching straw nodes keep the stem straight and form a restriction point which prevents water from travelling along the inside of the stem and so into the roof. Nodes are higher in sugar content than other portions of a mature stem and for this reason are the first point on a stem to be colonised by micro-organisms and the first point to show signs of degradation making node

condition a good indicator of the potential for early degradation in thatch. Fungal attack at the nodes will eventually weaken the joint and cause the stem to fracture; in a roof where many stems are attacked in this way, the fixings will eventually become loose and the roof will fail.

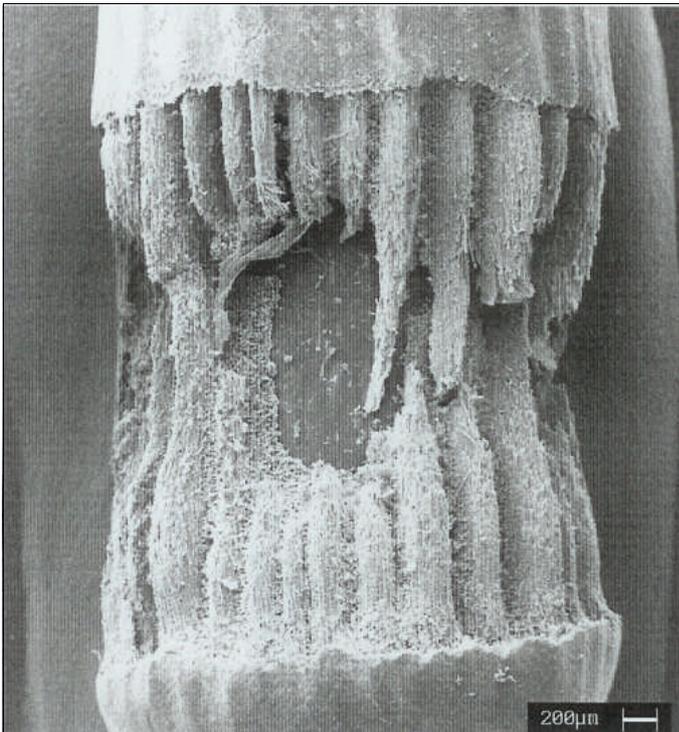
*Scanning electron micrograph of the node (joint) of the stem of thatching wheat Maris Wigeon which has been wetted when the yealm is formed. This had been on the roof for only three years. The joint is failing and the thatch stems will now no longer be secured by spars and sways allowing moisture prenatration into the thatch.*

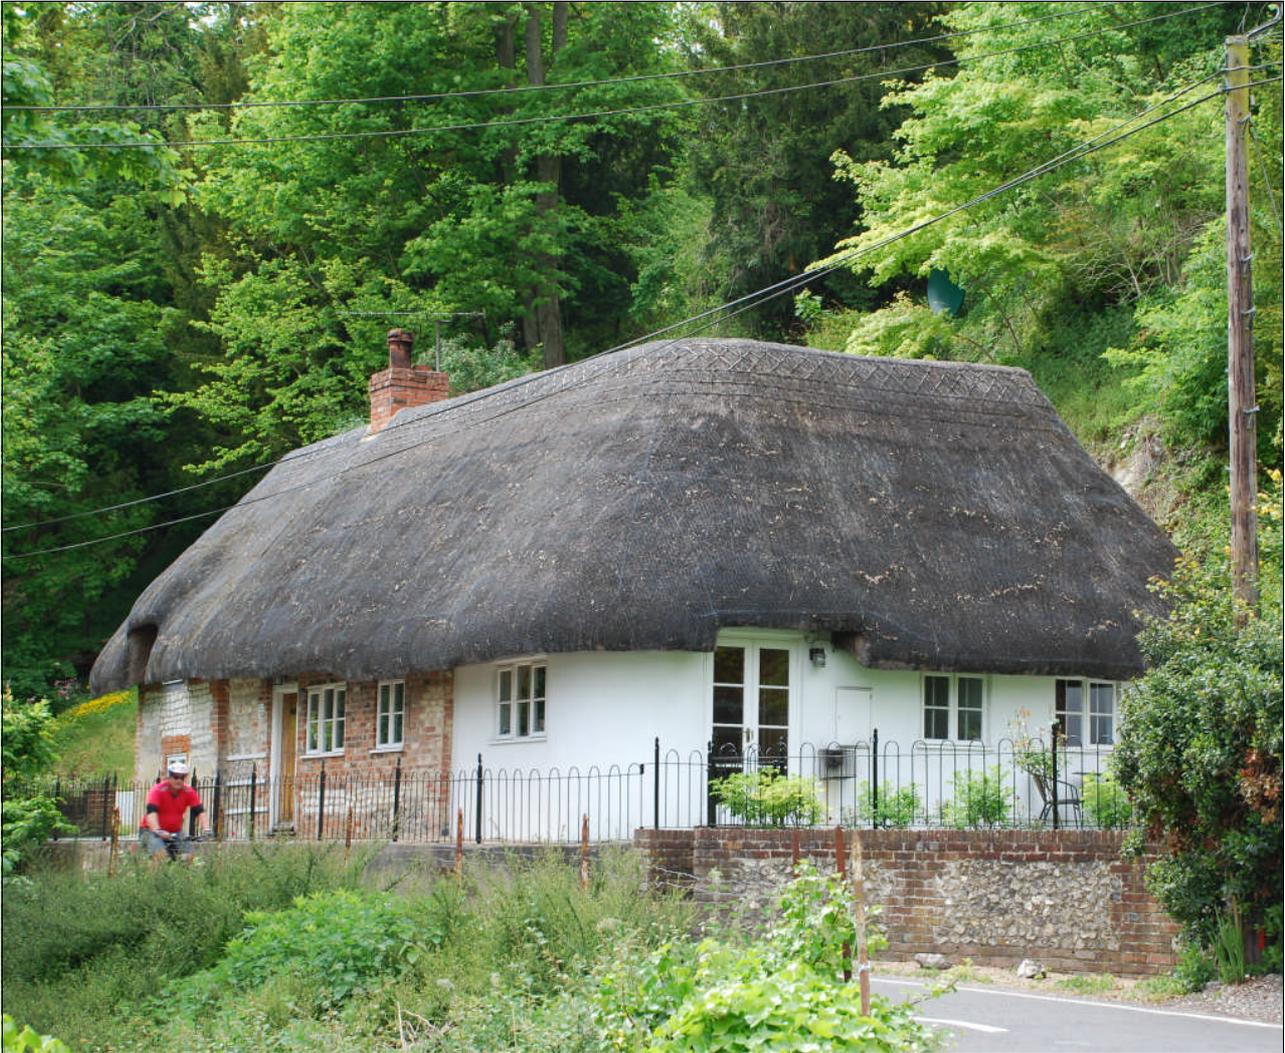
*Under trees and by the River Test. A harsh environment for thatch.*

Geographical location will influence the life of a roof; thatch tends to have a shorter life expectancy in the wetter Southwest of the UK than in East Anglia. Wooded areas, overhanging trees valley bottoms and proximity of a river or ponds will also adversely affect the life of a thatched roof.

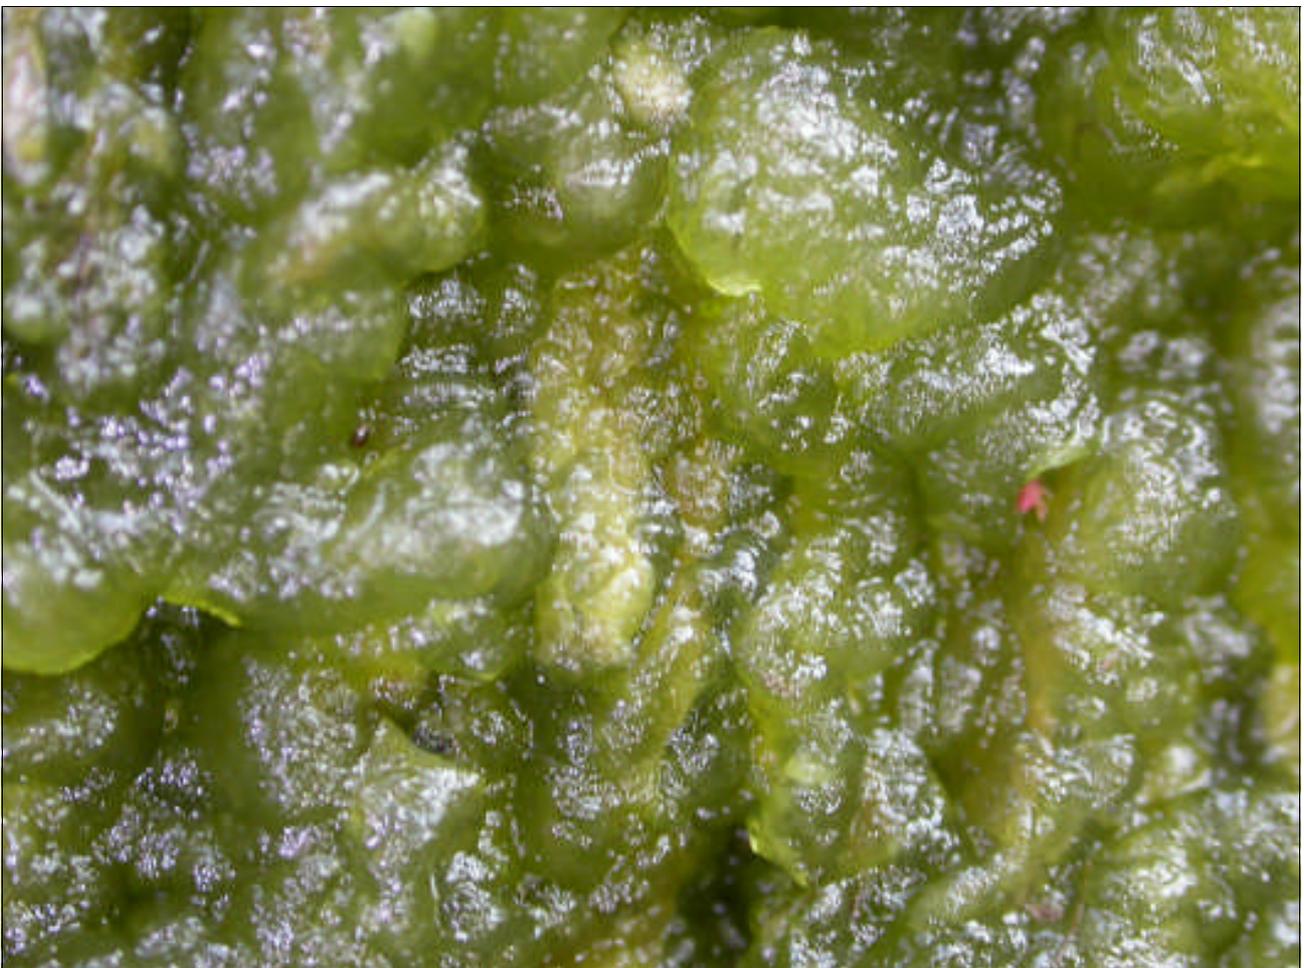
*Algae forming a biofilm on the north face of a roof in Devon. The algae form a mass of cells embedded in a mucilaginous gel. This holds moisture and inhibits the drying of the roof and when it does dry out, it forms a crust, which becomes brittle and cracks appear in the thatch.*

Algae are a large and diverse group of simple, plants, ranging from single celled to multicellular forms. Algae will colonise thatch in wet conditions, they do no harm but demonstrate

that the area is wet. In windy conditions and spells of hot dry weather will destroy colonies of algae by drying them out, as this dry material cracks it may flake from the surface, sometimes taking with it fragments of thatch to which it has adhered.

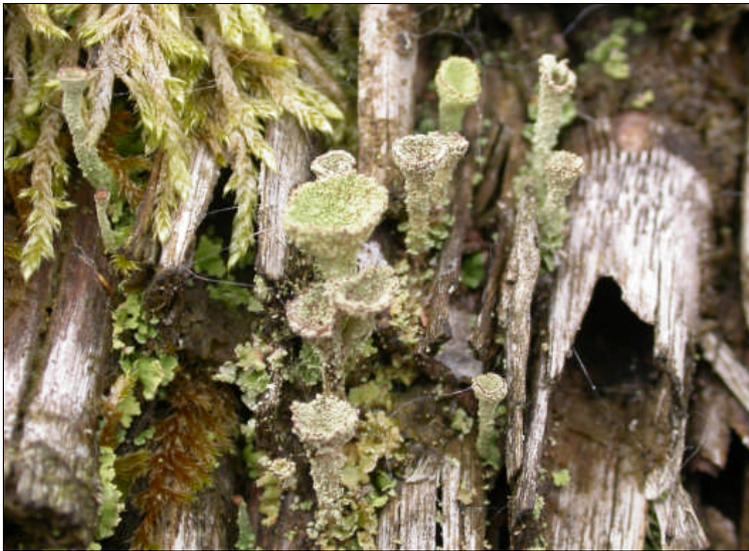
*Lichens and moss growing on water reed. Lichens are slow growing and indicate that this roof is not wearing quickly at the surface.*

Identifying mosses and lichens can often be confusing; in fact, the two organisms are radically different. Lichens are now considered to be fungi especially adapted to obtain food from algae living within their tissues. Lichens form a fascinating example of cooperative relationships in nature, with the fungus relying on the algae for energy, while the algae enjoy the

protection the fungus provides. Lichens most likely to be found on thatch are leafy or stringy (foliose) these can also be found growing on the ground or around trees. Lichens can be extremely

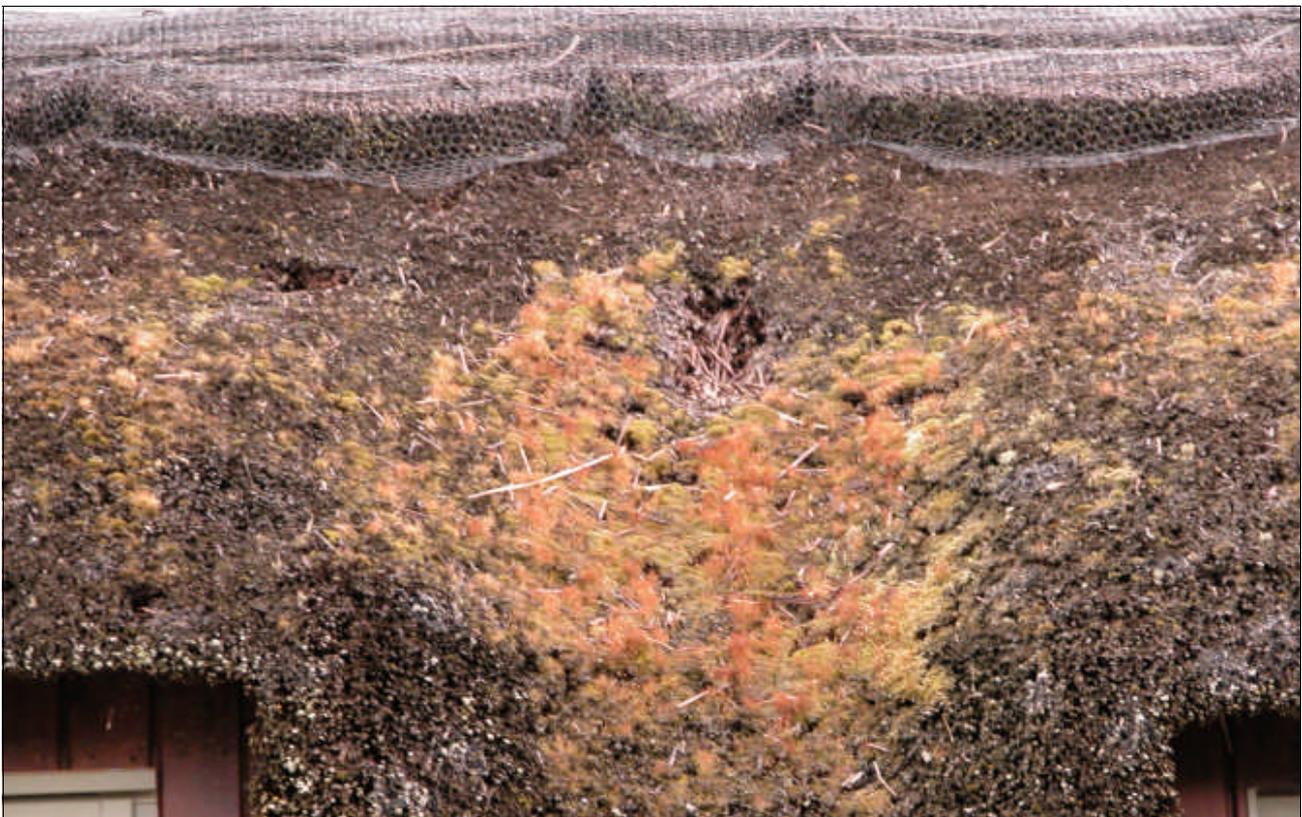
*Moss on north facing roof surface. There is also bird damage on this roof.*

Moss, on the other hand, is a plant; which reproduces by sending out spores, like lichen, moss can reproduce from broken off parts of the parent plant. In general, mosses grow in moist dark areas and have small leaf-like structures, in addition to stems. Lichens often appear grey or pale white in appearance, while moss is usually green.

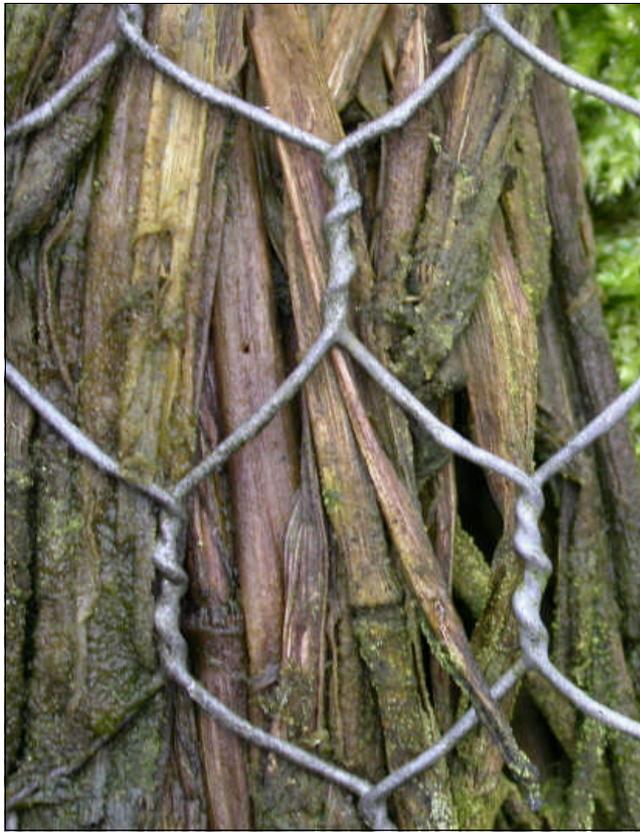
*Prolonged periods of rain encourage the colonisation of the straw thatch surface with algae and mosses. These hold moisture and prevent the thatch from drying out.*

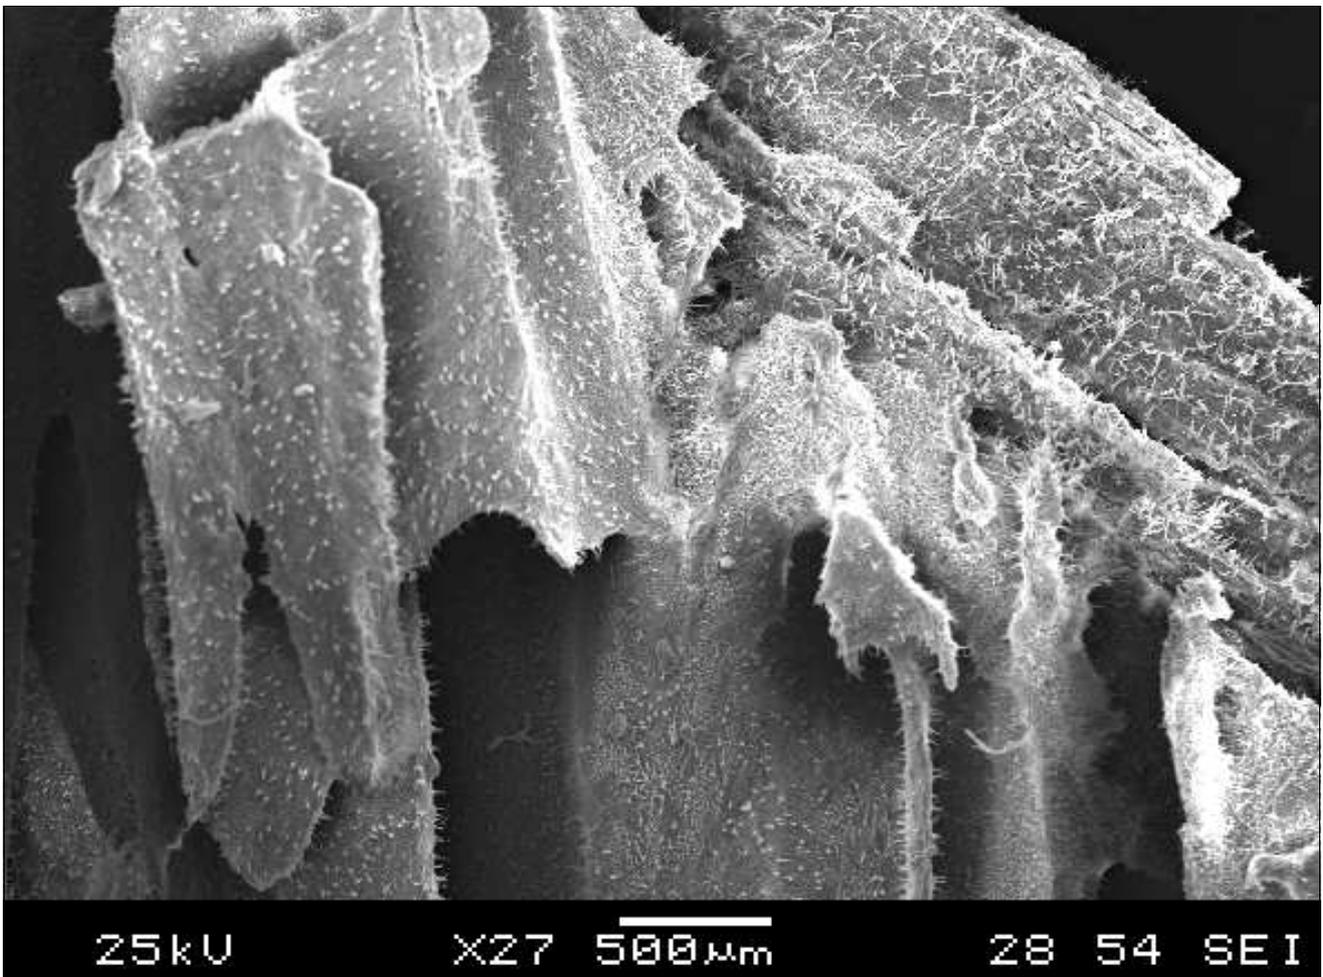
*Scanning electron micrograph of basidiomycete “gill structures” hanging from a length of reed in an advanced state of decay. The gills hang vertically from the underside of the straw and produce large numbers of spores. Most have been shed from these gills, leaving “pimples” where they grew.*

interaction with the thatch allows the ingress of water into underlying thatch layers providing conditions suitable for further degradation of the reed by fungi and a subsequent reduced life expectancy for the roof. The main body of research on decay of lignin rich materials has been carried out on wood and wood products. However, there are only a limited number of organisms that form symbiotic functions in the decay process many of these organisms appear to naturally colonise both wood and other decaying vegetation such as thatch. In this particular form of attack, decay is not homogenous across the whole surface of the coat work, but can be seen as “bleached” areas in either zones or patches; this type of decay is not necessarily associated with high wear areas of a roof such as the junctions of dormers, valleys or gullies. Stems taken from within these patches have often lost both tensile and compression strength causing them to collapse and fragment.
